## **Engineering Ethics: The Kansas City Hyatt Walkway Collapse**

# Engineering Ethics: Kansas City Hyatt Walkway Collapse

Edward P. Brunet, Jr., P.E.

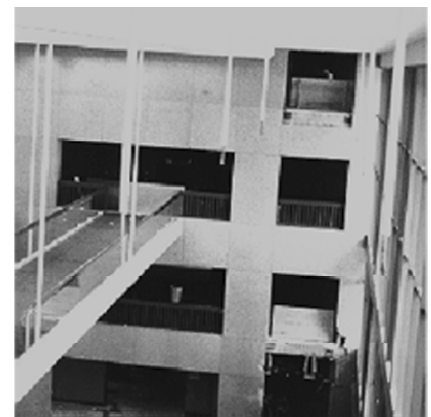
**Figure 1 - Third Floor Walkway (left)**

The proposed Kansas City Hyatt Regency Hotel consisted of three sections: a 40-story tower section, a function block, and a connecting atrium. The atrium, where the accident occurred, is a large open area approximately 117 feet wide x 145 feet long x 50 feet high. Three suspended "skywalks" spanned the atrium at the 2nd, 3rd and 4th floor levels. The 3rd and 4th floor walkways were each suspended from the atrium roof trusses, while the 2nd floor walkway was located directly underneath the 4th floor walkway and was suspended from the 4th floor walkway (see Figure 1 after the collapse showing the dangling 4th floor walkway rods to the right in the picture).

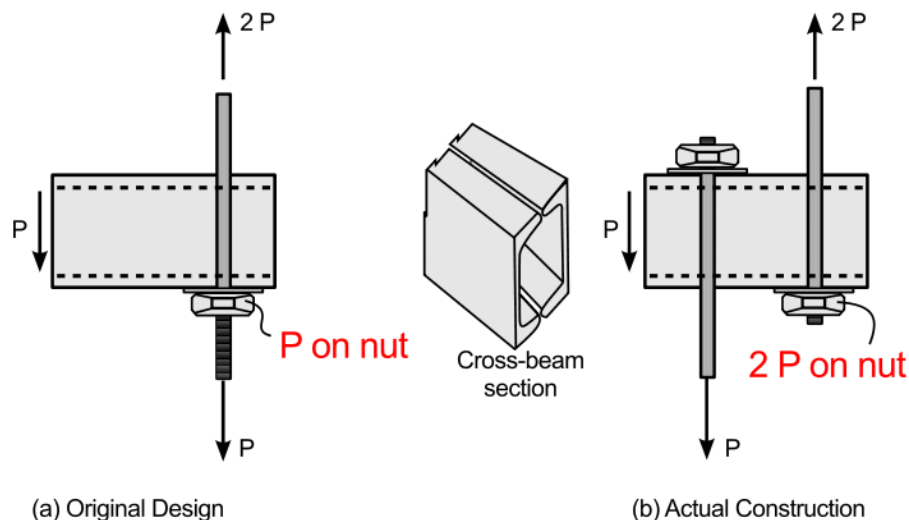
**Figure 2 – 4th Floor Atrium Walkway Box Beam Connection Detail**

The box beam members that formed the lateral structural support for each walkway were comprised of two (2) 8 x 8.5 MC channels welded toe-to-toe (see Figure 2a).

Secondly, the original design would have required threading the entire length of the long rod in order to install a nut under the 4th floor catwalk box beam. The nut for the 4th floor catwalk box beam would have to be installed after inserting the rod through the 2nd floor catwalk box beam, and would likely have required extensive scaffolding to complete the connection. This would have resulted in significantly higher erection costs. Further, Havens was concerned that the threads on the rod might be damaged during the erection process.

Therefore, Havens changed from a single to a double hanger rod box beam connection at the 4th floor catwalk (see Figure 2b). A rod was hung from the ceiling down to the 4th floor walkway. And a second rod was hung from the 4<sup>th</sup> floor walkway down to support the 2nd floor walkway. This allowed the use of shorter rods, which were readily available. It also simplified the erection process and eliminated the need for the entire rod to be threaded.

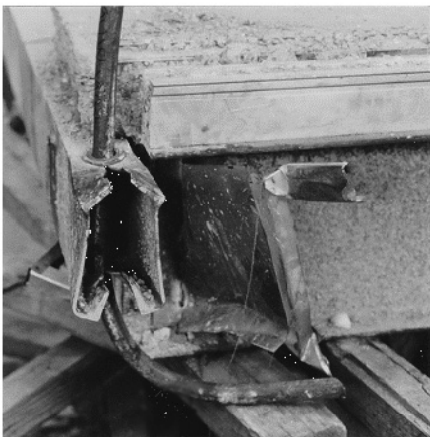
Figure 3 - Fourth Floor Walkway Box Beam Connection Failure

At the request of Kansas City’s Mayor, Richard Berkley, the National Bureau of Standards (NBS) – now the National Institute of Standards and Technology – initiated an investigation of the Kansas City Hyatt Regency Catwalk collapse. The NBS determined that the load at the bottom nut on the rod running from the 4th floor walkway to the ceiling had deformed the C-channels in the box beam. The weld joint between the two facing C-channels then split and the washer, nut and rod slipped through the box beam, resulting in the

collapse of the walkway (see Figure 3).

Because of the double rod design change initiated by Havens, the load at the nut on the 4th floor upper rod section was twice the load of the original single rod design. The investigation discovered that the original design could only support 60% of the load required by the building code. The shop drawing change to a two rod design doubled the load at the 4th floor connection, meaning that the as-constructed connection could only bear 30% of the mandated load.
