Engineering Ethics: The Kansas City Hyatt Walkway Collapse

Engineering Ethics: Kansas City Hyatt Walkway Collapse

Edward P. Brunet, Jr., P.E.

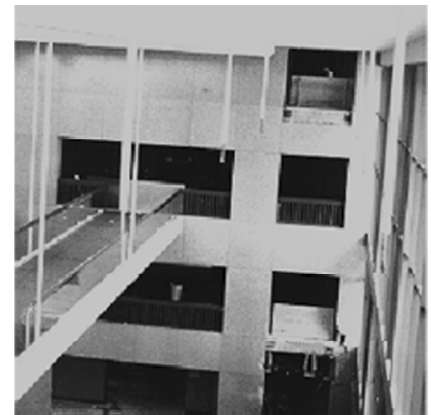
Figure 1 - Third Floor Walkway (left)

The proposed Kansas City Hyatt Regency Hotel consisted of three sections: a 40-story tower section, a function block, and a connecting atrium. The atrium, where the accident occurred, is a large open area approximately 117 feet wide x 145 feet long x 50 feet high. Three suspended "skywalks" spanned the atrium at the 2nd, 3rd and 4th floor levels. The 3rd and 4th floor walkways were each suspended from the atrium roof trusses, while the 2nd floor walkway was located directly underneath the 4th floor walkway and was suspended from the 4th floor walkway (see Figure 1 after the collapse showing the dangling 4th floor walkway rods to the right in the picture).
